Conducting Walk Audits

Route: North Monroe Street Riverside Neighborhood Loop

Hosts: Spokane Regional Health District in partnership with Riverside Neighborhood Council and Downtown Spokane during the Downtown Spokane National Night Out Against Crime

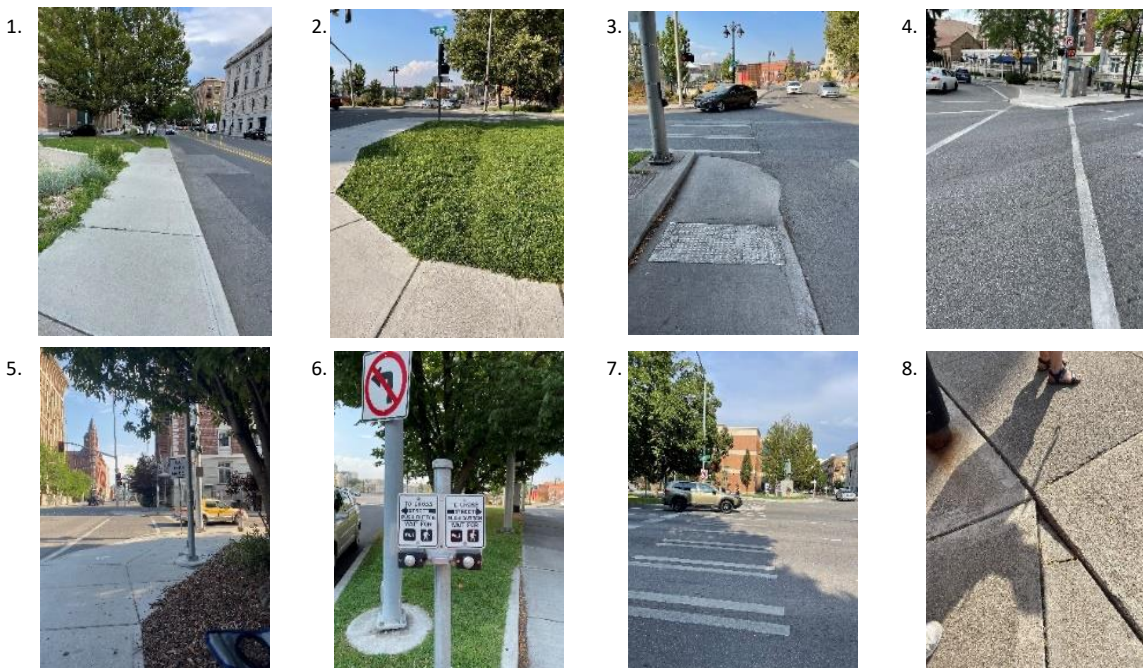
1. West Main Avenue on the pedestrian island with the Lincoln Memorial Statue headed towards the Spokane Public Library – Central — the sidewalk leads to grass and no place to cross North Monroe Street in the direction of the library

2. West Spokane Falls Boulevard on the pedestrian island with the Lincoln Memorial Statue — pedestrian path is worn in the grass
3. West Spokane Falls Boulevard on pedestrian island without a statue at the North Monroe Street crosswalk — the pedestrian signal is at a different level than the sidewalk, the sidewalk narrows, debris on navigation strip, no clear corner to separate pedestrians and vehicles

4. Crossing North Monroe Street towards the pedestrian island on West Riverside Avenue — the navigation strip leads the pedestrian into a space that is used by turning vehicles and pedestrians

5. Car taking a right turn at the red light from North Monroe Street to West Main Avenue where there is a no turn on red sign
6. Crosswalk pedestrian buttons on the pedestrian island on North Monroe Street and West Spokane Falls Boulevard

7. Vehicle stopped at the red light blocking the marked crosswalk
8. Crack in the sidewalk on the southeast corner of North Monroe Street and West Main Street near the permanent bollards

- Update crosswalk signals at all intersections to include auditory prompts, decrease wait times to be signaled to walk, and increase the walk time specifically when crossing North Monroe Street
- Move navigation strips on corners away from traffic (turning vehicles)

- Increase the width of sidewalks that narrow at corners
- Add safety barriers between the sidewalk and street
- Improve infrastructure for bicycles and electric scooters
