## Conducting Walk Audits

**Route:** North Haven Street Hillyard Neighborhood Loop

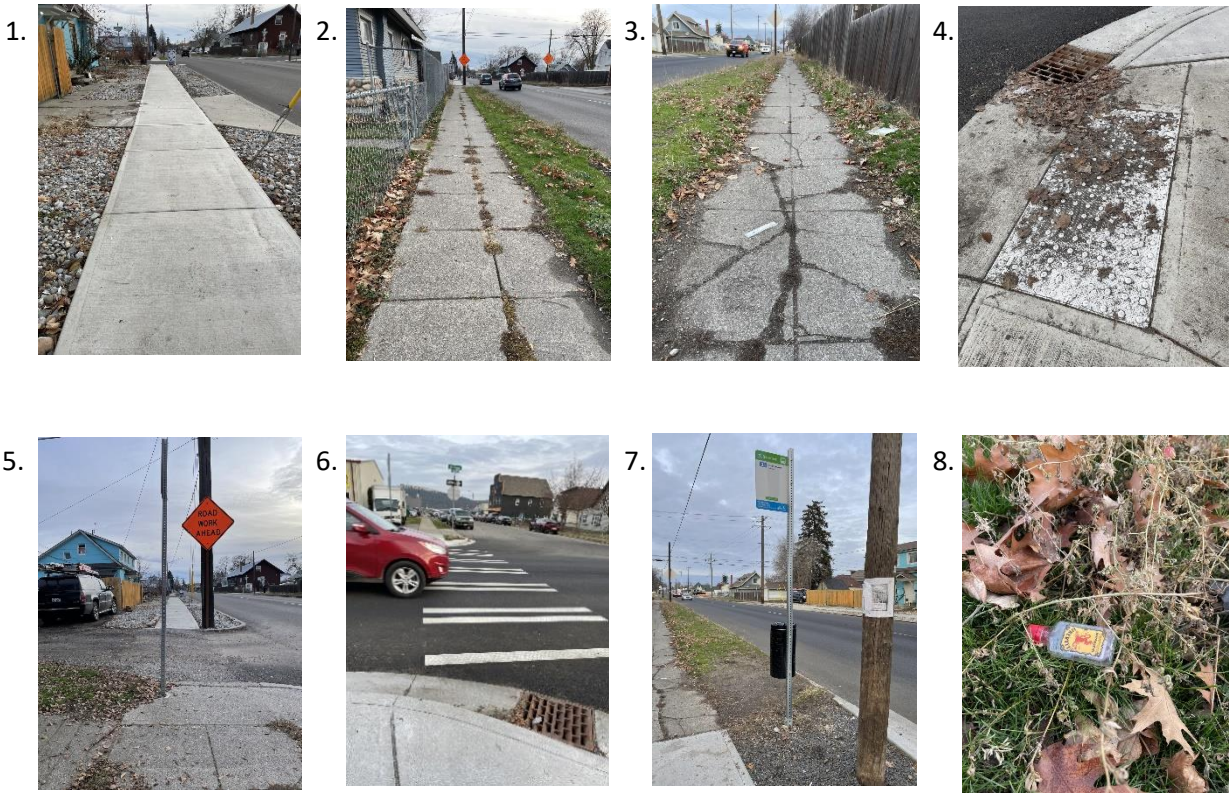
- One section of the route had newly-paved sidewalks and the corners were all newly paved and had tactile navigation strips. The remaining sidewalks had many large cracks that raised the surface by two inches. Many of the sidewalks were narrowed by overgrown landscaping and had grass growing in the cracks.
- Auditors noted that vehicles seemed to be traveling above the speed limit and did not stop at the marked crosswalk for pedestrians.
- There was litter throughout the route, even at the bus stop that had a trash receptacle. Litter consisted primarily of empty alcoholic beverage containers and dog waste.
- There was one Spokane Transit Authority bus stop on the corner of North Haven Street and East Diamond Avenue.
  - The transit stop does not protect waiting passengers.
  - The auditors would not feel safe waiting in this location.

1. Sidewalk on North Haven near Red Dragon Northside
2. Sidewalk on North Haven at the start of the route with grass that is growing over the seams and edges
3. Sidewalk near the bus stop on the corner of North Haven with several large cracks
4. Tactile navigation strip at the end of the route with debris
5. Alley crossing on North Haven with rocks and debris
6. Crosswalk on North Haven at the end of the route where traffic was not stopping for pedestrians
7. Bus stop on the corner of North Haven Street and East Diamond Avenue
8. Close up of litter found on the route

- Repair sidewalks. Bus stop sidewalk repairs will increase accessibility and safety for bus riders.
- Improve landscape maintenance to widen sidewalks.
- Introduce data-driven interventions to reduce litter and discourage littering. For example, add ballot bins, trash receptacles at specific locations, and neighborhood dog waste disposal stations.

- Add pedestrian “bulb-outs” at crossings to increase visibility of pedestrians preparing to cross and reduce vehicle speed.
- Add pedestrian-friendly lighting to pedestrian walkways.
