Conducting Walk Audits

Date and time: Dec. 12, 2024, 3:45-4:15 p.m.

Route: East Frederick Avenue Minnehaha Neighborhood Loop

Hosts: staff from Spokane Regional Health District

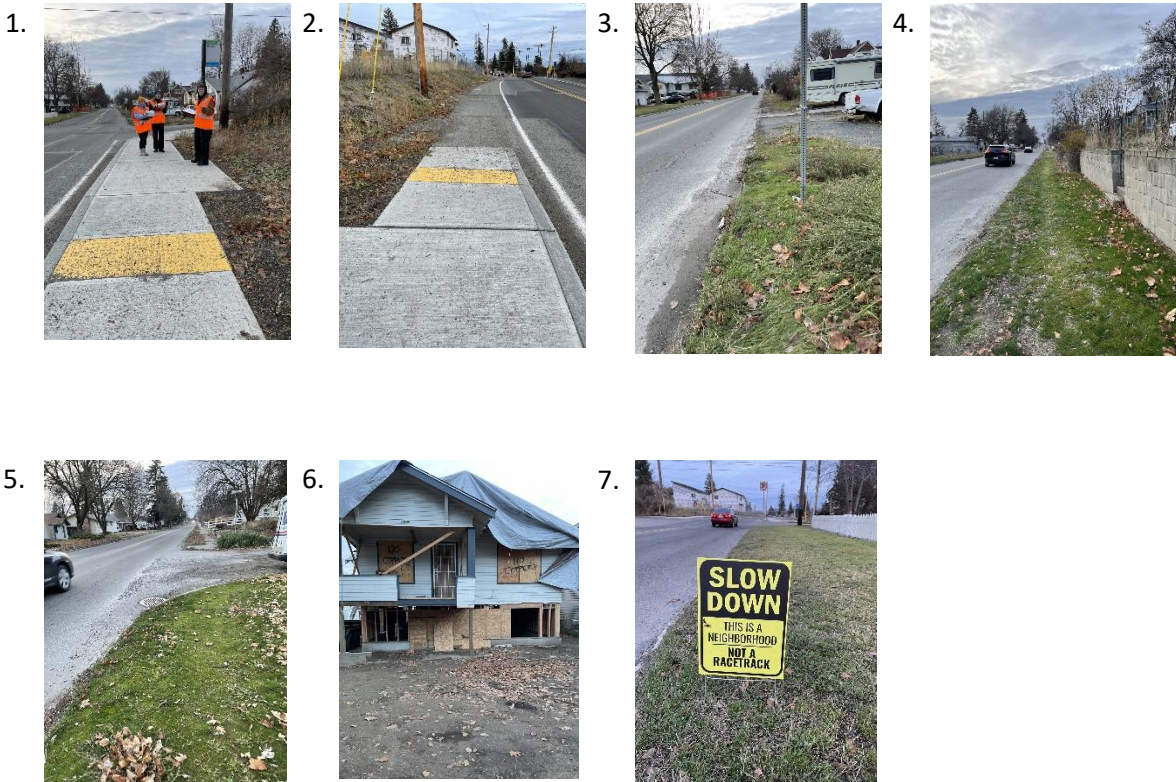
- The bus stop (ID 4720) on East Frederick Avenue had a paved area, tactile navigation strips with curb cuts and was in good condition, looking like it had recently been paved. The sidewalk for the bus stop did not lead to a connected network and was covered in gravel and debris from the surrounding area.

- The route showed evidence of pedestrian use: pedestrian walking paths crossed through the grass areas along the street. This was most obvious along East Frederick Avenue.

- There were no crosswalks or connected pedestrian paths to access the bus stops in the area or the park from the residential area.
- Auditors observed fast-moving traffic while walking the route. There was a sign in one of the yards requesting vehicles to travel at a slower speed, which was evidence that the fast-moving traffic was an ongoing issue for pedestrians in this area.

1. Bus stop (ID 4720) at Frederick and Havana with sidewalk, tactile navigation strips, and curb cuts
2. End of bus stop sidewalk looking down East Frederick Avenue away from the route
3. East Frederick Avenue — pole with no trucks symbol just off road blocking what might be the walking path
4. Pedestrian walking path in grass along East Frederick Avenue
5. Corner of East Frederick Avenue and North Cuba Street with gravel in the intersection
6. House on East Frederick Avenue that is under construction
7. Sign placed in yard along street to encourage slower traffic speeds

- Add sidewalks and crosswalks that create safe routes to access the park and the bus stops.
- Add traffic calming elements to reduce high traffic speeds throughout the route.

- Add pedestrian-friendly lighting to pedestrian walkways.
- Add outdoor seating, shelter from the elements, and a trash receptacle for public use at the bus stop.
- Conduct a neighborhood-wide campaign to encourage responsible waste management behaviors that would result in less litter.
