Conducting Walk Audits

Date and time: July 16, 2024, 8-9 a.m.

Route: Northeast Community Center Bemiss

Neighborhood Loop

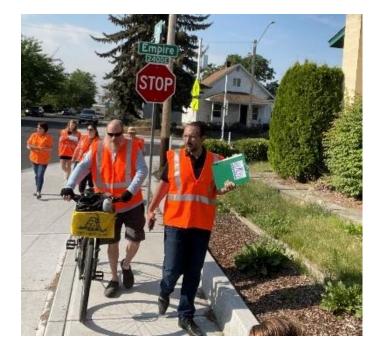
- At the North Cook Street and East Empire Avenue intersection, there were button-activated flashing signs.
- Most of the route had curb cut ramps where the sidewalk was interrupted by a street. The direction of the curb-cut ramps was frequently unsafe along North Crestline Street as it directed pedestrians into traffic or the bicycle lane.

- 1. North Cook Street near the Heritage Heights Apartments with barrier for pedestrians
- 2. Crosswalk on East Empire Avenue with button activated flashing light and small post
- 3. Curb cutout on North Crestline Street heading into the bike lane and traffic
- 4. Sidewalk section on East Providence Avenue with crumbling material
- 5. Raised sidewalk sections of up to two inches on East Providence Avenue due to tree root
- 6. Landscaping obstacle on North Crestline that was 20 feet long down the sidewalk
- 7. Debris in bike lane (garbage and rocks up to two inches in diameter)
- 8. Close up of bike lane debris
- 9. Bus stop on North Crestline

- Add pedestrian-friendly lighting to pedestrian walkways
- Add safety barriers between the sidewalk and street
- Add outdoor seating for public use at the bus stop
- Create a four-way stop at the East Empire Avenue and North Cook Street intersection

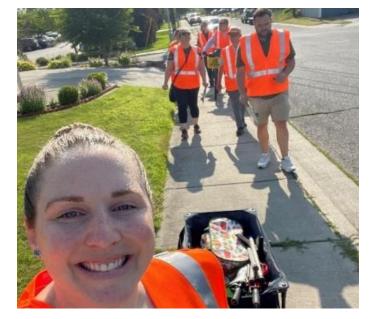
- Much of the route had poor sidewalk conditions, including raised sections from tree roots and cracks. This makes sidewalks difficult for pedestrians to navigate.

- Repair sidewalks
- Improve landscape maintenance
